Manhole Inspection Summary

Manhole # S13GG_018MH

Insp Date: **3/6/09 1:41 PM**

Location Address: **DUKELAND ST**

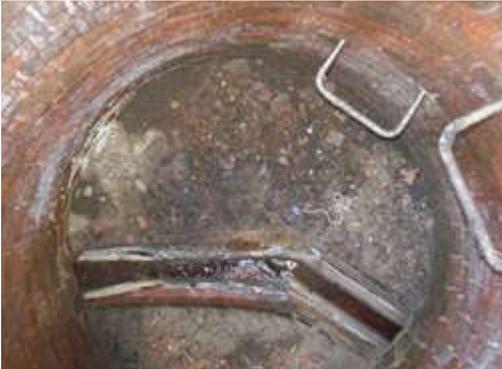
Defect 1

DEBRIS ON BENCH

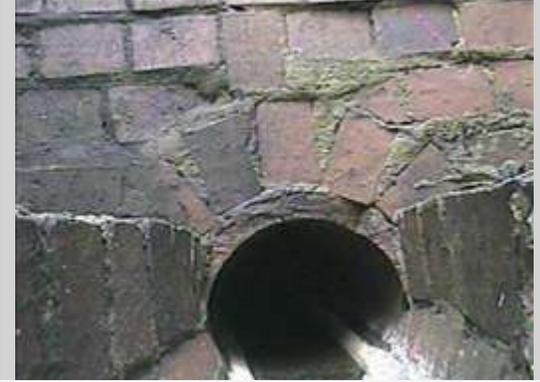
12 O'Clock Outflow

8 in. Circular Gravity Sewer
Pipe Out @ 12 O'Clock

Pipe Height: (in.) Direct
Pipe Material: **Clay** Pipe Lined
Invert Depth: **6.64** (ft.) Flow Characteristics: **Slow**
Deposits: None Mud Sludge Debris Grease
Silt Depth: (in.) Deposits Extent:
Infiltration: **None** Pipe Seal Cond: **Sound**

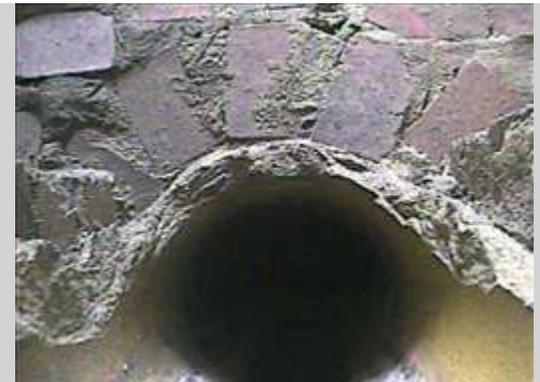
7 O'Clock Inflow

8 in. Circular Gravity Sewer
Pipe In @ 7 O'Clock

Pipe Height: (in.) Direct
Pipe Material: **Clay** Pipe Lined
Invert Depth: **6.45** (ft.) Flow Characteristics: **Slow**
Deposits: None Mud Sludge Debris Grease
Silt Depth: (in.) Deposits Extent:
Infiltration: **None** Pipe Seal Cond: **Sound**
